The British Archeological Project at Grumentum: 2017 Season

Final report on the 2017 excavations in Settore S, Grumentum

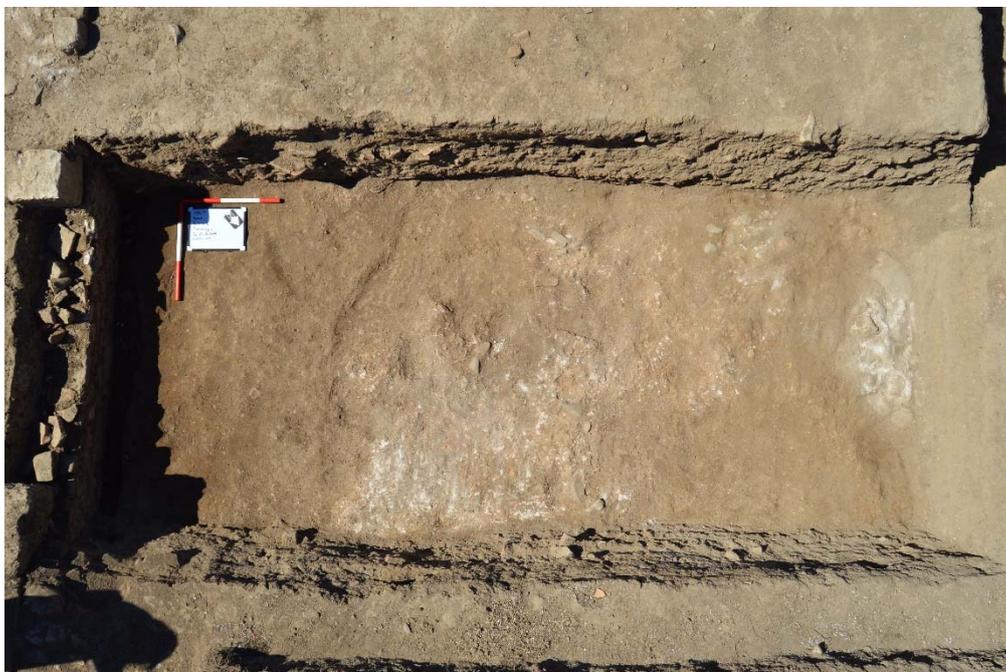
Fig. 4 Sounding 5, 2016. Partial remains of mortar floor US 6418 (centre) and the top of the semicircular structure US 6421 (right)

During the 2016 season, however, we made a number of discoveries that called aspects of this interpretation into question. Excavations in Sounding 5, which is positioned laterally across the width of the road, revealed a mortar floor (US 6418) and semicircular structure (US 6421) at a depth of c. 1.6m from the surface (Fig. 4). Pottery recovered from the structure's construction cut and the strata associated with the floor date both to the mid-2nd century AD. In Sounding 4, we found a sandstone column base underneath the column platform in northeastern part of the sounding (Fig. 5), reused as part of the foundation. A fragment of a near-identical base was recovered from the upper strata of Sounding 8 (Fig. 6), next to the remains of a column built in *opus latericium*. These two revelations indicate that the situation in Settore S is more complicated than previously imagined. First, the presence of the mortar floor US 6418 and "structure" US 6421 (at the moment, we are uncertain as to the purpose of the architectural feature) confirm that the space between the eastern building facades and the colonnade served as road only in late antiquity: prior to this it was probably an interior space. Second, the discovery of the sandstone column bases suggests that there was another phase of the colonnade, one that existed prior to the construction of the column platform in Sounding 4 and the *opus latericium* columns found throughout the area (as will be outlined below, we now believe that there at least three phases of the colonnade).

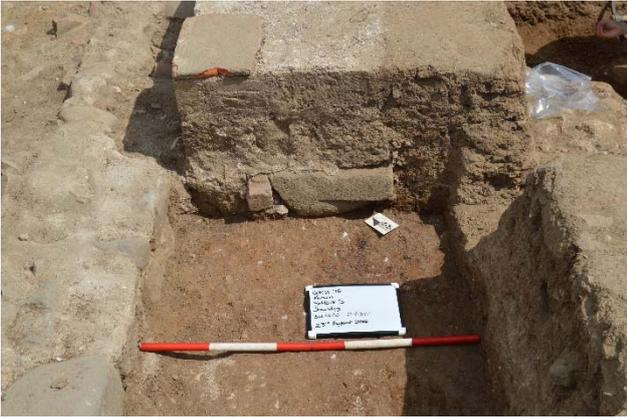
Fig. 5 Sandstone column base identified below platform in Sounding 4

In 2016, the foundation trench (US 6204) for column platform US 6266 was identified along its southern and western sides, revealing, among other things, part of a sandstone column base (US 6392) that was incorporated into the foundation.¹⁰ This season we were able to excavate the northern side of the cut, confirming the hypothesis that platform US 6266 is of relatively late date (i.e. 3rd or 4th c. AD). Its construction required alterations to many of the structures thus far identified: to the south the cut

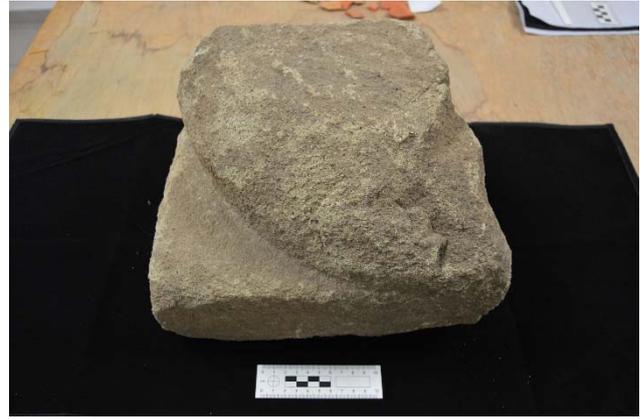
Fig. 6 Sandstone column base recovered from Sounding 8

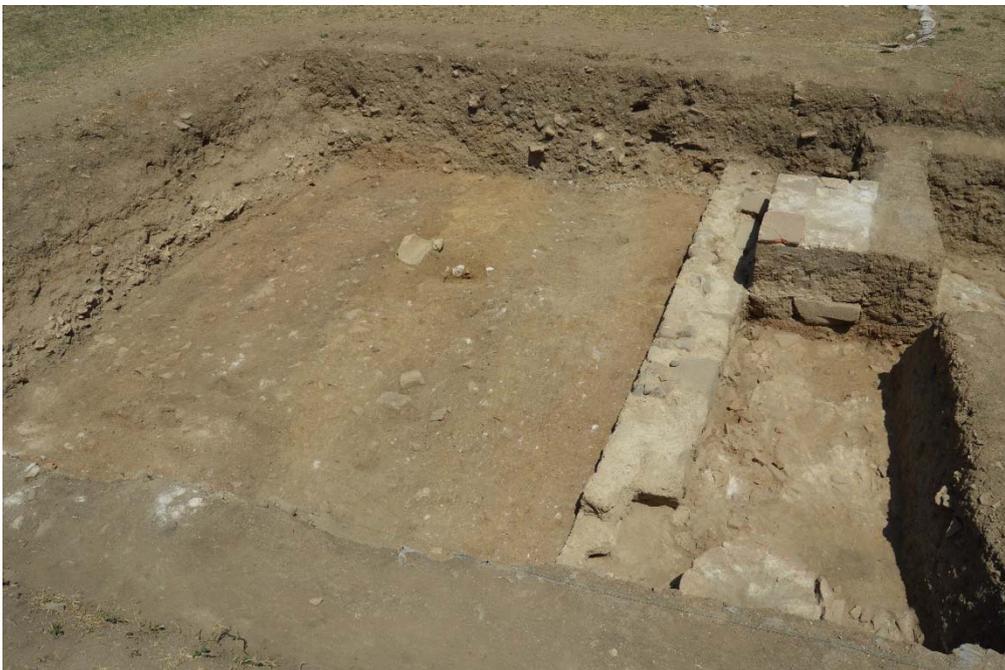
Fig. 7 The eastern (right) and western areas of Sounding 4, bisected by wall US 6003. View from south at close of 2017 season

As in the preceding years, the situation in Sounding 4 shows substantial differences between the areas to the west and east of wall US 6003: evidently these two spaces were used for different purposes, and thus this report will be organised accordingly (Fig. 7). The two areas have not been excavated to the same depth, and virgin soil has not been reached. The main results can be summarised as follows.

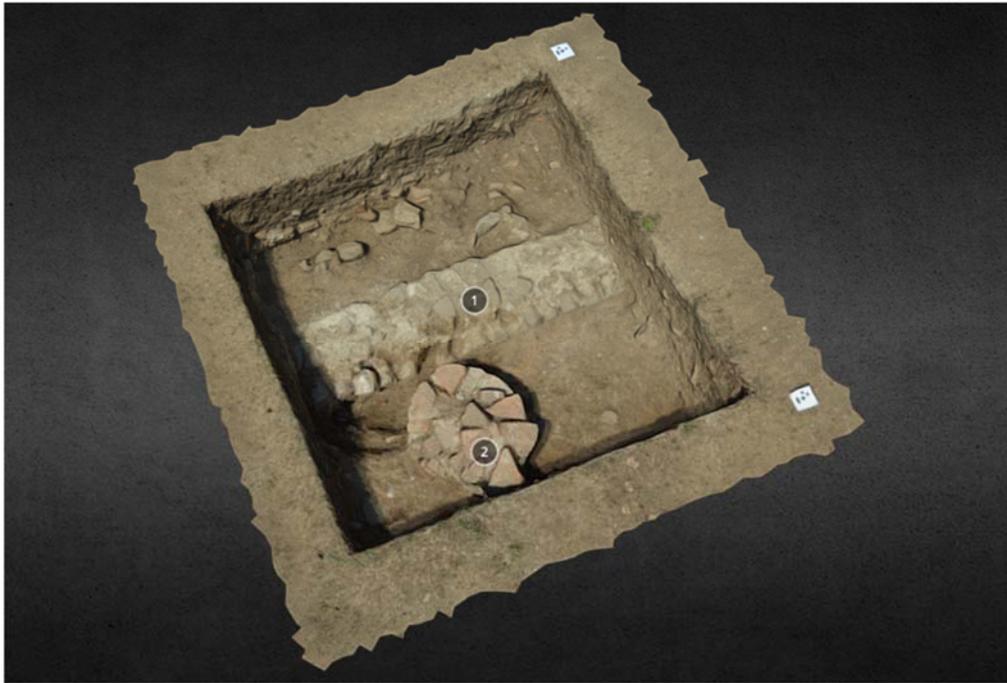
Fig. 10 Photogrammetric model of Sounding 8 at close of 2016 season. Both wall US 6003 (1) and column US 6415 (2) visible at comparatively shallow depth. View from the east

⁵ This is similar to what was found during the 2016 season in Sounding 8. Here wall US 6003 was also discovered, but at a much shallower depth compared to Sounding 4. In Sounding 8 we did not excavate deep enough to reach the bottom of the wall, but we could observe that the masonry of the western face was composed of fist-sided river stones, rather than larger ones (perhaps these are located at the foundation level of the wall, as in Sounding 4).

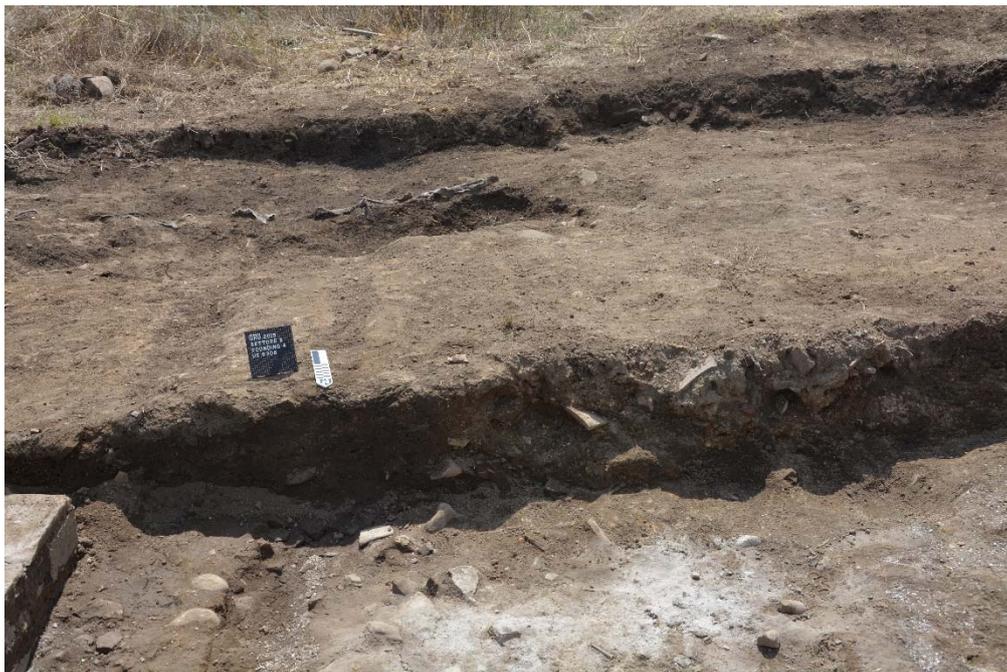
Fig. 11 Sounding 4 in 2015, south wall. US 6306 is visible on the left side of the image, running underneath the photoboard and north arrow and above the top of wall US 6003

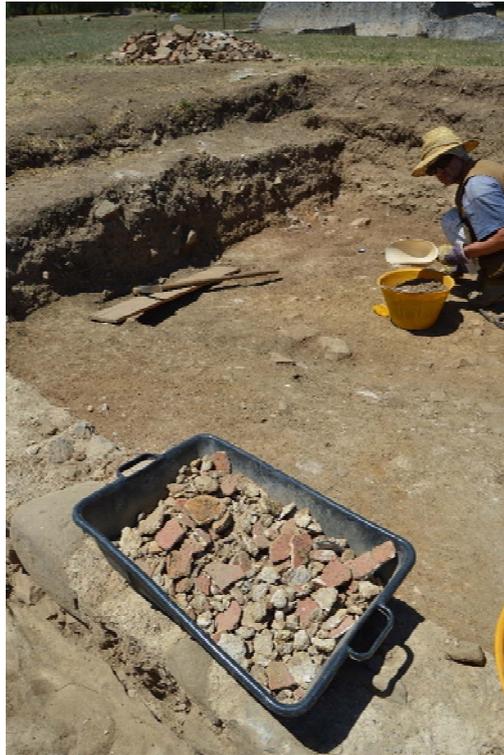
Fig. 12 Painted wall plaster collected from US 6497

One of these sloping surfaces (US 6497) contained huge quantities of painted wall plaster alongside mortar, bricks and roof tiles (Fig. 12). The plaster fragments were primarily painted red, but also displayed blue, yellow and pink hues, and a handful presented identifiable design elements, such as stripes or swirls. Almost all of the fragments were found face down, indicating that they were probably attached to the western face of wall US 6003. Charcoal was also found throughout this context; it was in some cases attached directly to the plaster itself, which suggests that fire was perhaps the cause of the fresco’s destruction. Obviously, this discovery adds a complicating element to the hypotheses laid out during the discussion of the eastern area: if the painted plaster was attached to wall US 6003, then the latter was probably not a low terrace-wall bordering the portico, but rather a much higher structure of yet undetermined purpose.

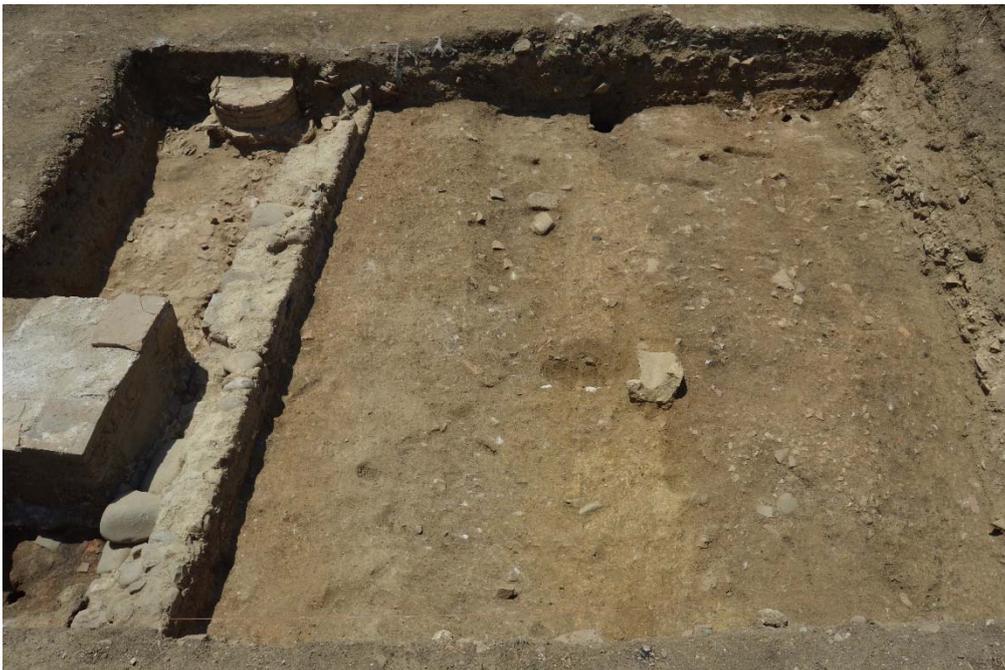
Fig. 13 Sounding 4 at conclusion of 2017, view from north

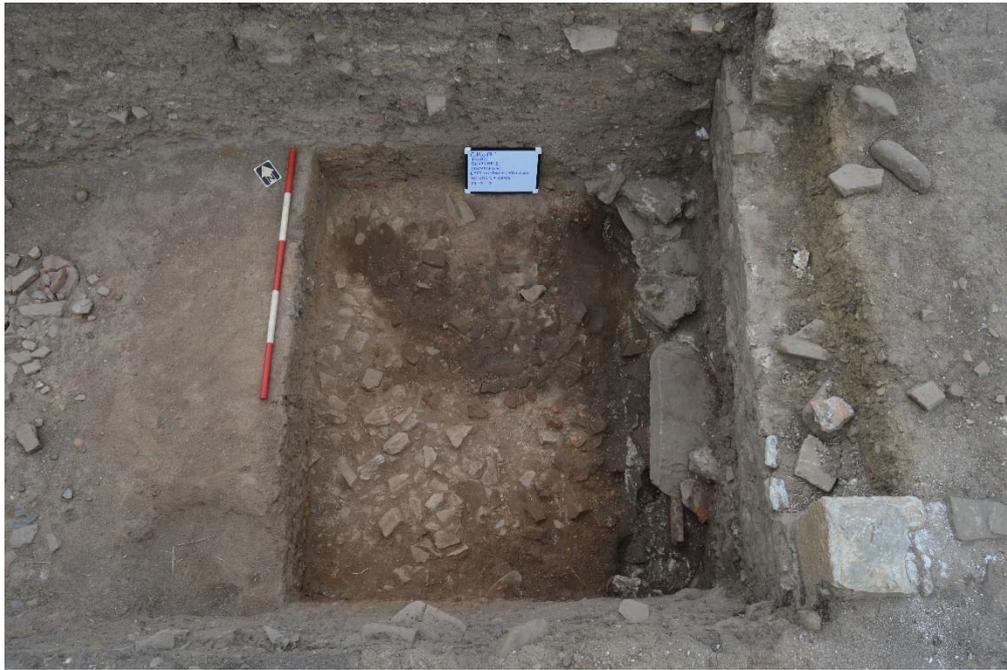
Fig. 16 Sounding 5, eastern window. Surface US 6554 visible on the left, wall US 6540 on the right

Tile, brick, and stone surface **US 6554** was the oldest layer revealed in Sounding 5, and indeed in the entirety of Settore S (Fig. 16). The surface was revealed in the "East Window" excavations (Fig. 17); this window was opened in the eastern third of the sounding in order to continue stratigraphic excavations without disturbing mortar surface **US 6495**, which extends westward into Sounding 4 (where, as noted above, it is called **US 6482**). **US 6554** was comprised of broken roof tile, brick, and ceramic sherds (all coarse ware) in a red clay matrix. This surface is thought to represent a preparation layer for the clay walking surface **US 6535**, positioned immediately above it. At the far eastern edge of the window, positioned underneath wall **US 6264**, the top of wall **US 6540** was identified. Both of the surfaces to the west were cut by **US 6527** (fill **US 6474** and **US 6425=6492**) during the construction of this wall.

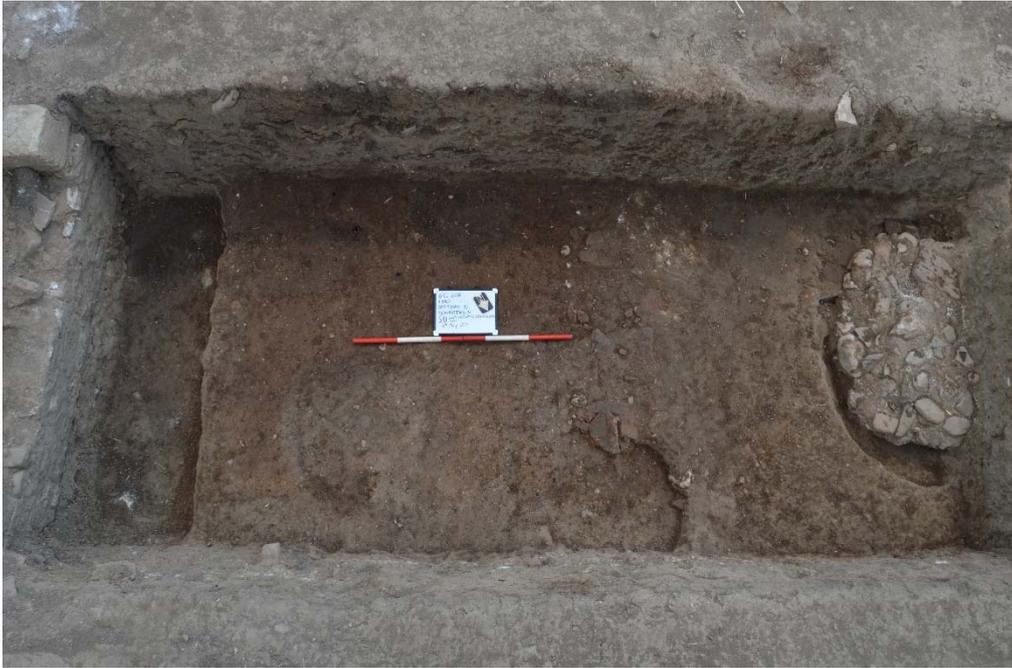
Fig. 18 Circular pits cut through US 6485 and US 6489 in eastern part of Sounding 5

Several small (~30cm diameter), shallow (10-20cm) pits were observed in lens US 6485 and layer US 6489 (Fig. 18). These were cuts **US 6504**, **6505**, **6506**, and **6450**; the latter was first identified and excavated in 2016. Each of these pits were multi-layered and cut both contexts US 6485 and US 6489, with the exception of US 6450, which contained only a single fill deposit, and US 6504, for which only a single layer (**US 6490**) has been excavated in 2017. It is likely that a second, underlying layer exists, and thus it has been pre-emptively numbered **US 6582**. Detailed descriptions of the four cuts follow below.

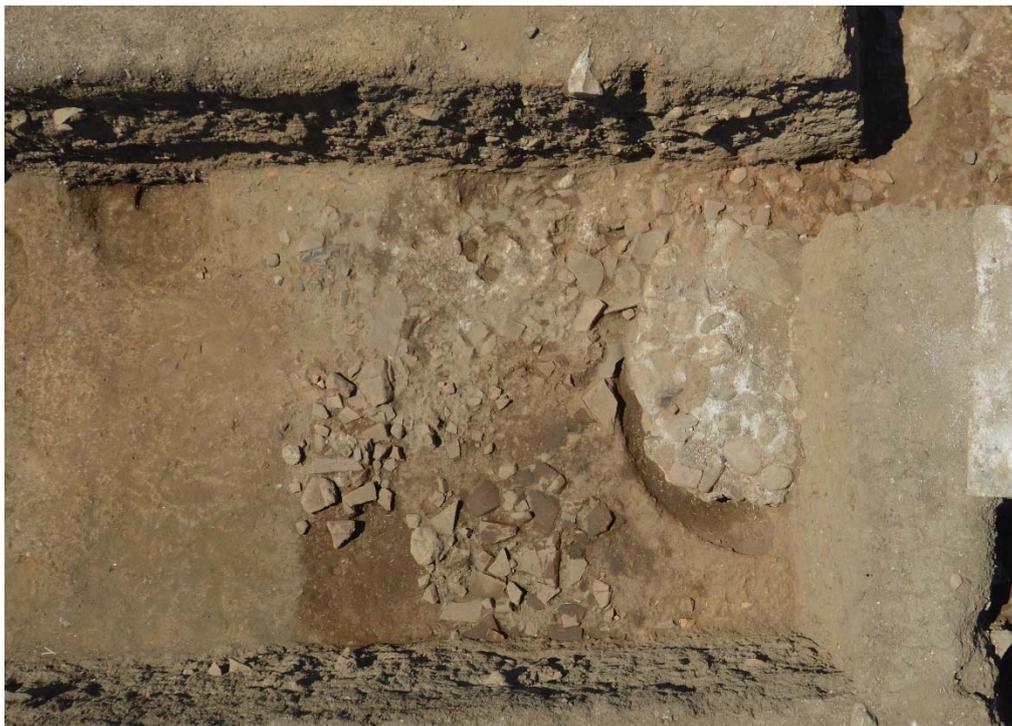
Fig. 19 Surface US 6495, cut US 6447 and semicircular structure US 6421. View from the north

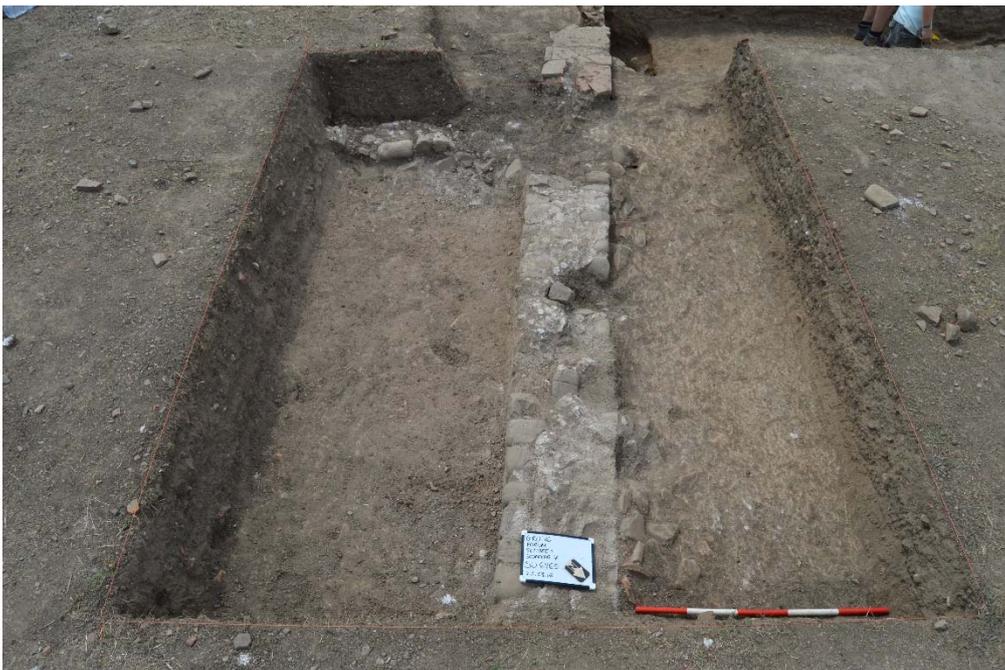
Fig. 21 Wall US 6264, with debris from various collapse/destruction events visible to the west. Photo taken prior to extension of the sounding to the east

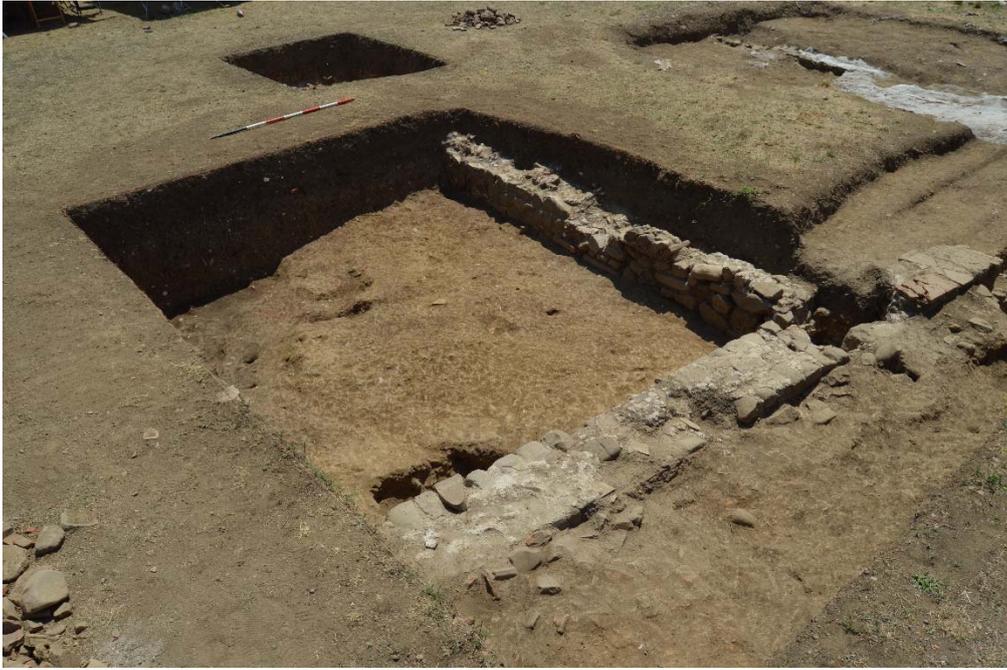
Fig. 22 Sounding 7 at close of 2017 season, displaying walls 6264 (foreground) and 6464 (background). View from northwest

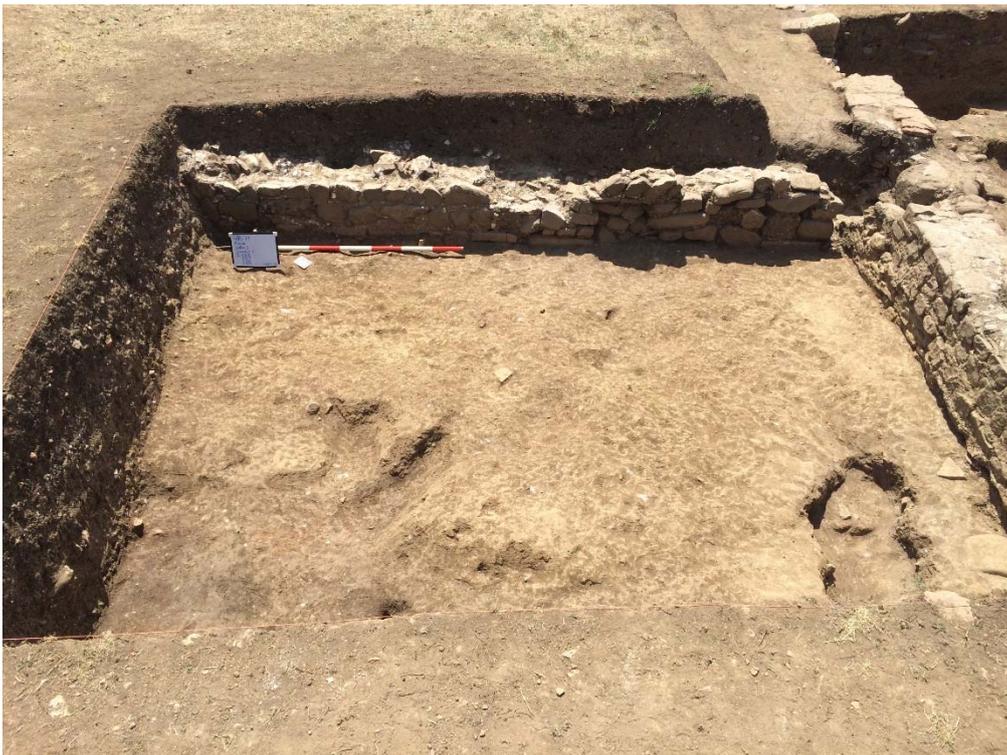
Fig. 23 Sounding 7 at close of 2017 season, view from north. Cut US 6567 visible in bottom right

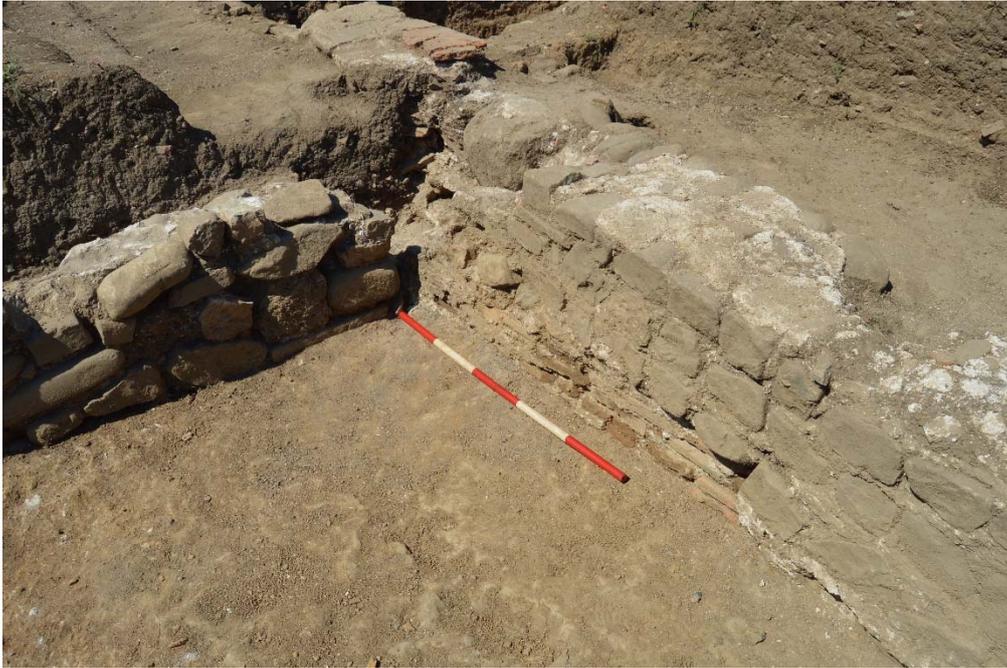
Fig. 24 Junction of walls US 6264 and US 6464. The upper courses of *opus latericium* wall US 6538 visible to the right of the metre stick

There are also some interesting observations regarding the walls US 6264 and US 6464. At their junction is a large cut (**US 6519**) that destroyed a section of wall US 6264. It was filled with three different contexts: the uppermost layer, with soil similar to the topsoil US 6201, was **US 6471**; this was followed by a layer consisting of loose mortar and brick fragments (**US 6513**), and finally a reddish and black soil with mortar inclusions (**US 6517**). After removing the fills, it became apparent that the walls are not bonded, but that wall US 6464 abuts wall US 6264. The cut was most likely a robbing action in order to extract stones. Upon the removal of the layer US 6536, the top of the earlier wall **US 6583** appeared underneath the southern extent of wall US 6264 (Fig. 24). Unlike its later counterpart, this structure was rendered entirely in *opus latericium*. It follows the orientation of wall US 6264, and, from a chronological perspective, probably corresponds to the construction of wall **US 6373** discovered in Sounding 5 during the 2015 season. This wall is positioned underneath the southern part of wall US 6264; it seems to have been covered by the construction of latter in the 2nd or 3rd century AD. The build date for US 6373/6583 is uncertain at this point.

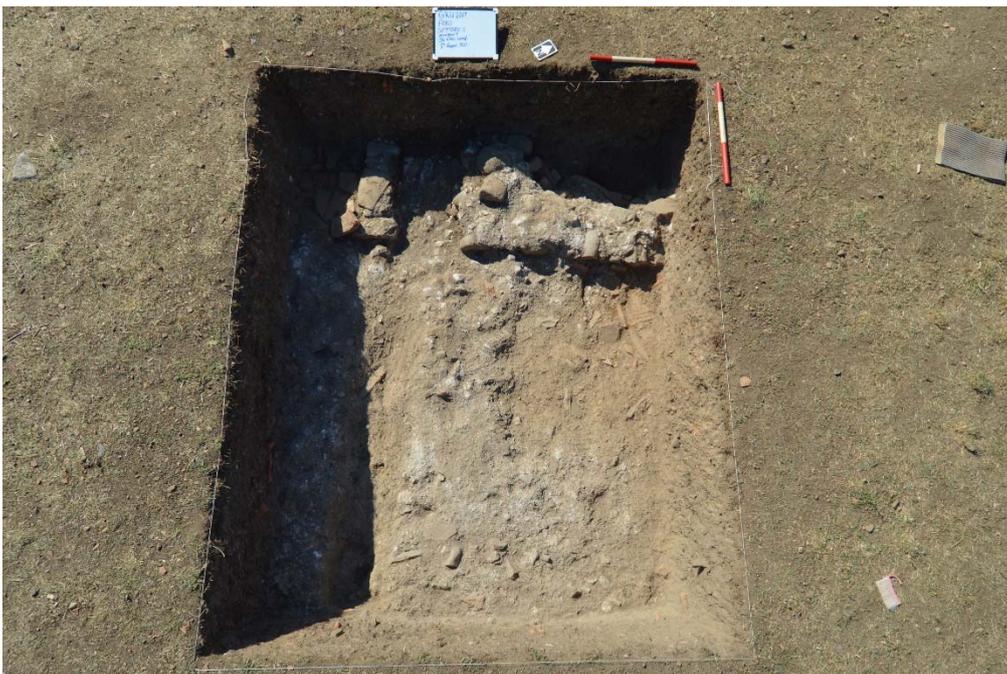
Fig. 25 Mortar surface US 6560 and wall US 6561 in Sounding 9

Overlying the tile surface, US 6560 was a level mortar layer that abutted wall US 6561 and extended across the sounding towards the east (Fig. 25). The mortar of surface US 6560 was white, crumbly, and of non-uniform thickness, with greater depth observed towards the south. This variation in thickness is likely a result of attempts to level the surface. US 6560 may also be associated with US 6584, a line of mortar containing medium-sized (up to 10cm) stone and tile inclusions observed along the eastern wall of the sounding. Though the character of the mortar is similar in term of colour and consistency, the inclusion of stones and tiles was not observed elsewhere in US 6560, and the linear nature of US 6584 suggests a distinct architectural action.

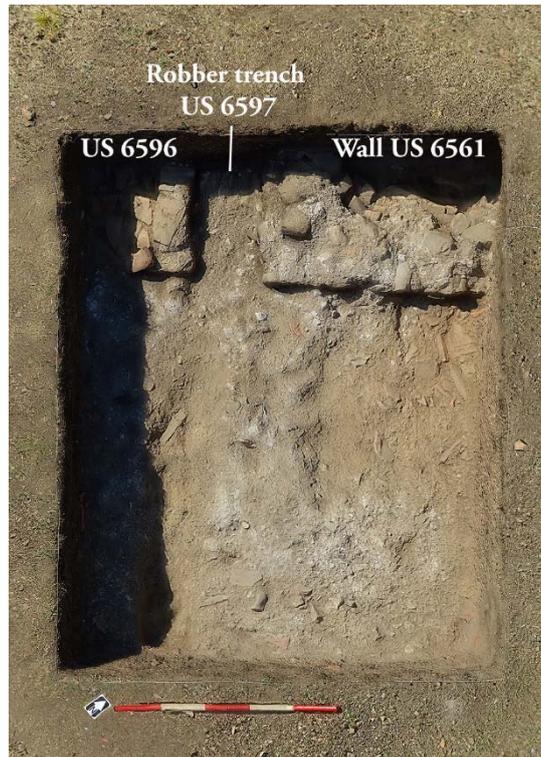
Fig. 26 Orthophoto of Sounding 9 depicting the relationship between wall US 6561, robber trench US 6597 and structure US 6596

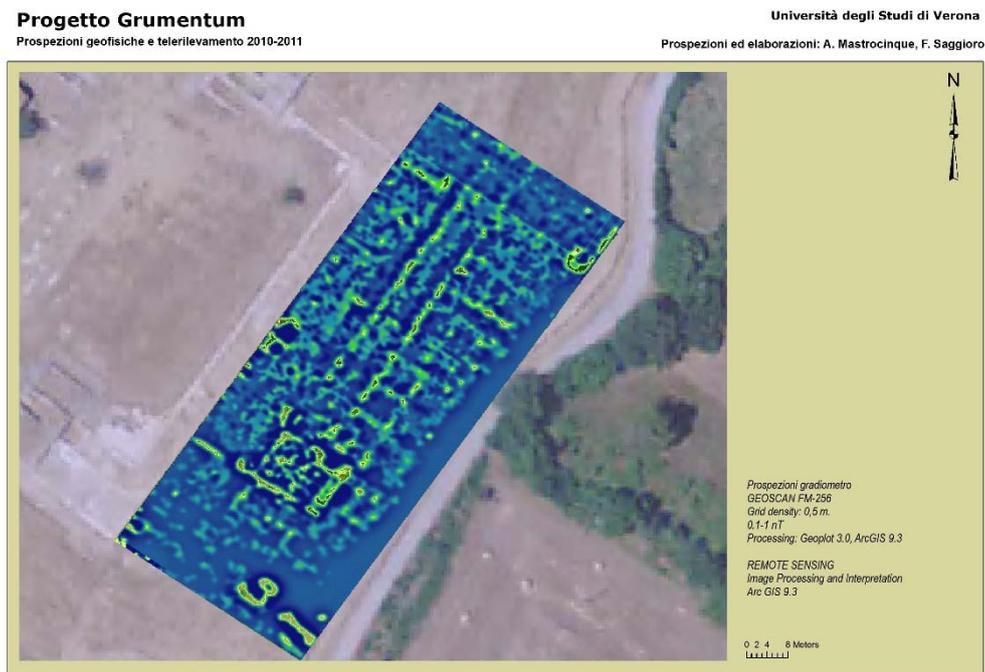
Fig. 27 Results of magnetometer survey conducted in 2011, indicating that the line of rooms identified on the east side of Settore S continue northward
