The British Archeological Project at Grumentum: 2018 Season

A report on the excavations in Settore S, Grumentum

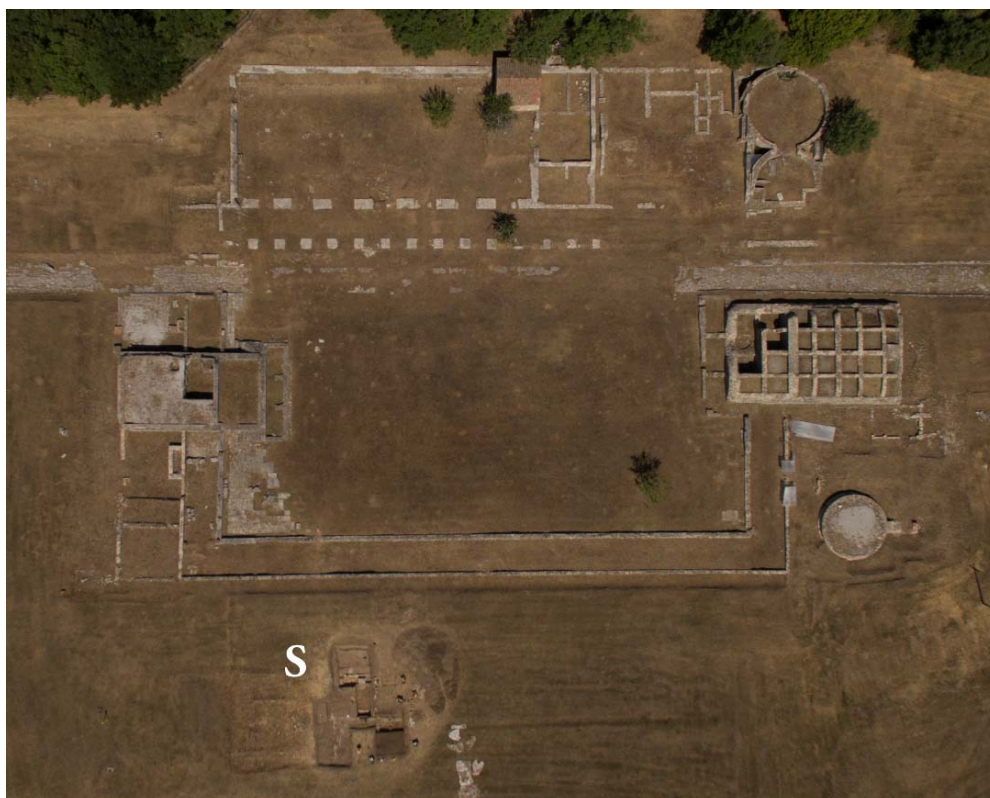
Fig. 1 Forum of Grumentum, photographed in 2017; “S” indicates location of the BAPG trench

In August 2018, the British Archaeological Project at Grumentum (hereafter BAPG) completed its fifth season of fieldwork in Settore S at Grumentum (Fig. 1). The project was initiated in 2014 and is exploring the growth of Grumentum's commercial and industrial economies between the late Republic and the early Dominate. Previous excavation campaigns in Settore S have shed light on the nature of the archaeological remains in the area. In 2009 and 2010, Vincenzo Scalfari of the University of Verona opened a large trench adjacent to the forum's southeast corner. The primary aim of this excavation was to test the results of a geophysical survey, which seemed to indicate the presence of a large building complex running roughly parallel to the forum (Fig. 2). Although Scalfari's campaigns were inconclusive—he postulated that the area was home either to a building complex or a house—the results of the BAPG's excavations have confirmed the existence of a single, elongated structure positioned parallel to the forum's east wall. The building is composed of two main components: a series of rooms, each measuring approximately 33 m², and a wide colonnaded *porticus* situated to their west (Fig. 3). It appears that each room was accessible only via a doorway opening off the *porticus*. The entire structure was probably erected in the early 3rd century AD, and was subject to multiple phases of subdivision and reconstruction over the following centuries. The colonnade, in particular, was rebuilt on multiple occasions, with the last of these events probably occurring in response to fire that broke out in the 4th century.

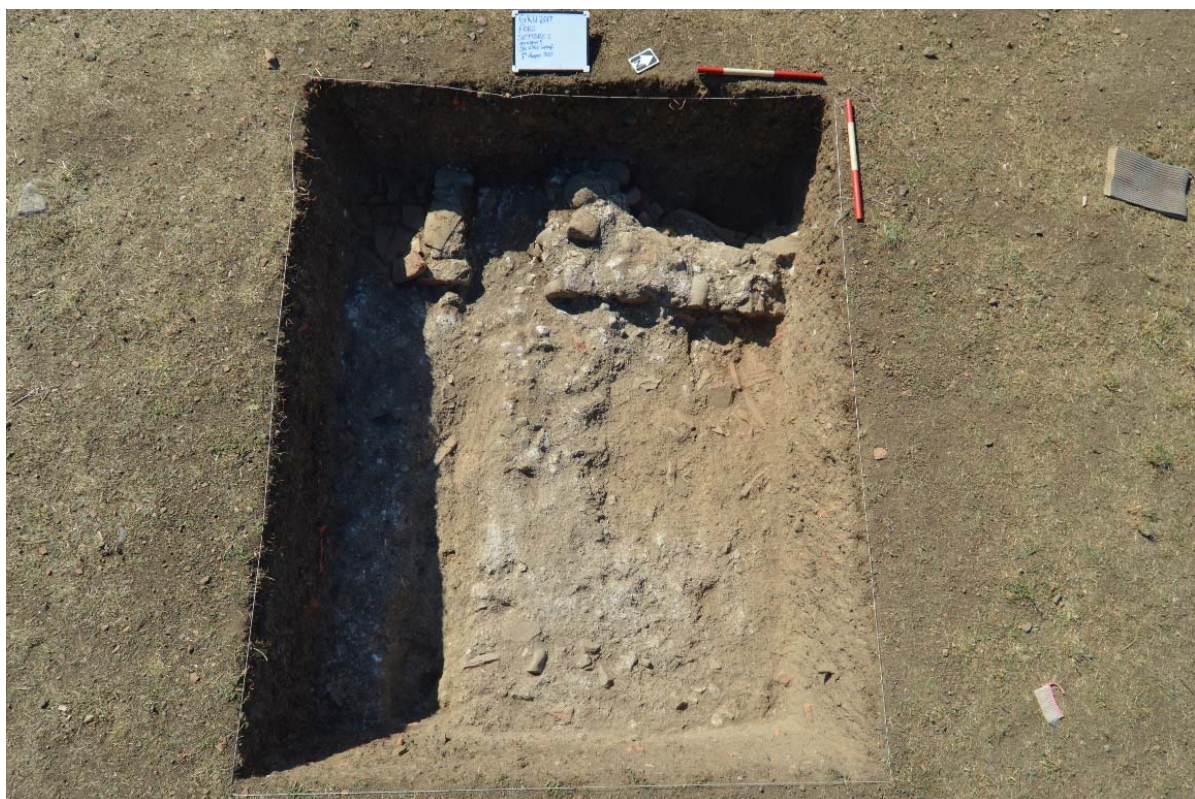
Fig. 4 Mortar surface to the west of wall US 6561 in Sounding 9, during 2017 season

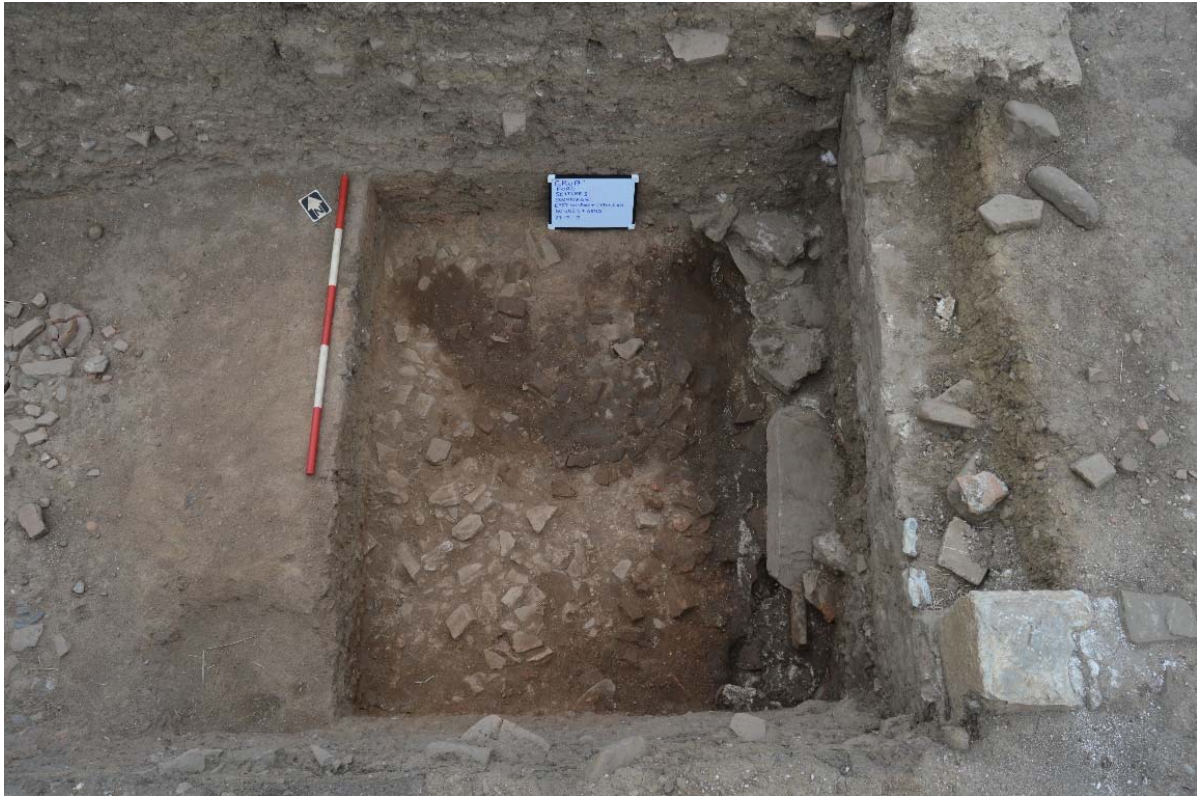
Fig. 5 Sounding 5 during the 2017 campaign. Surface US 6554 visible on the left, wall US 6540 on the right

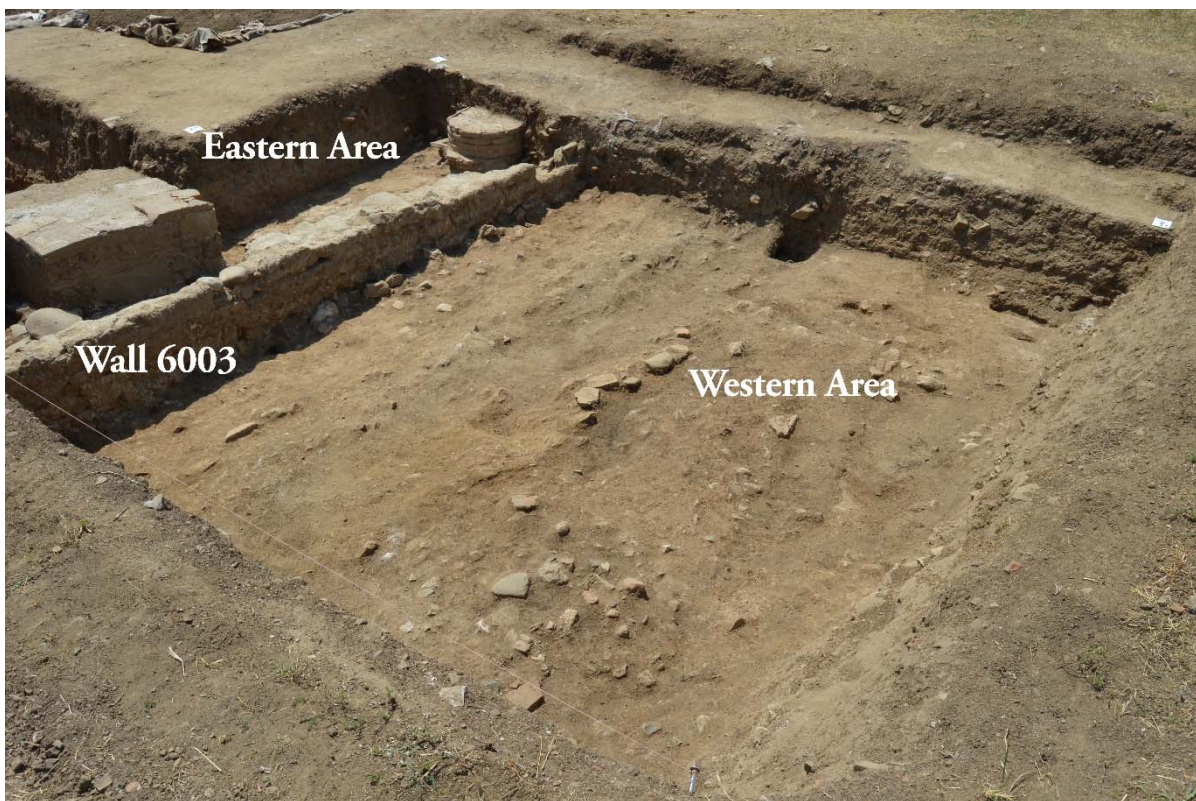
Fig. 6 Sounding 4 at the conclusion of the 2018 season; view from northwest

Sounding 4 is characterised by different contexts on the two sides of wall 6003, a structure that runs roughly north-south and divides the sounding in a larger western area, and a smaller eastern one (Fig. 6), which contains a small section of the *porticus*. The western area is composed of a sequence of deposits and limited walking surfaces, which have been interpreted thus far as artificial surface elevations intended to match those occurring in the *porticus* to the east.

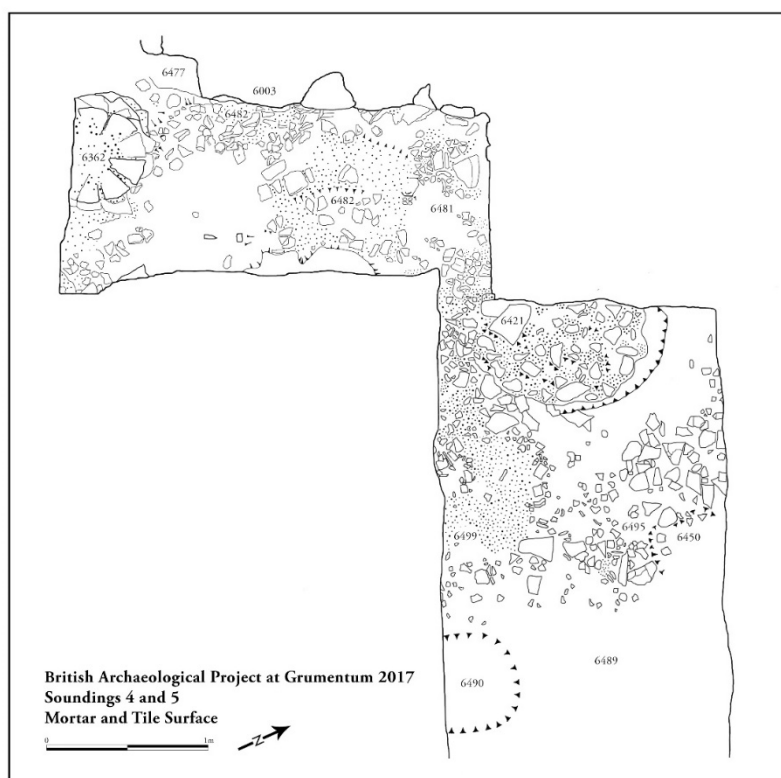
Fig. 7 Plan of “conglomerate” surface US 6482-6495 in Soundings 4 and 5, recorded in 2017

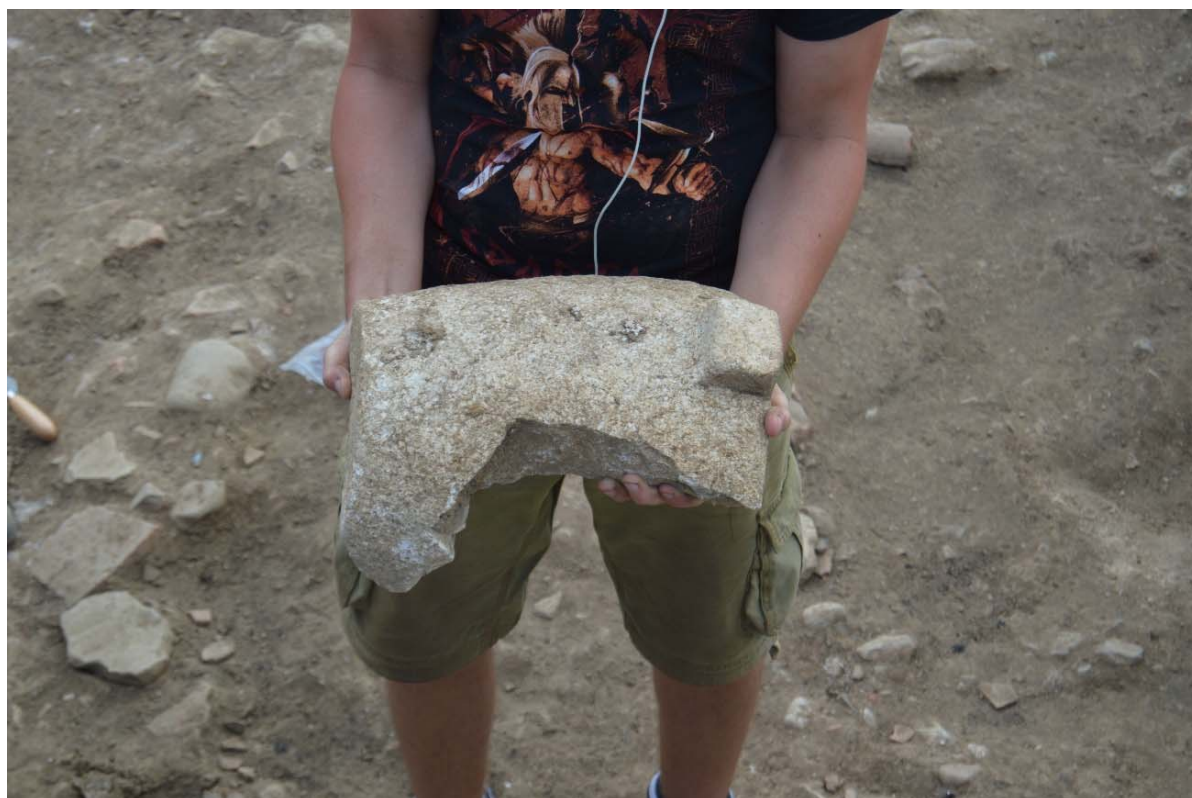
Fig. 8 Broken *mortarium* recovered from US 6635 in Sounding 4

The finds this year have been underwhelming both in quality and quantity. Beyond the ceramic, only one illegible bronze coin was found (US 6609), and a quarter of a broken *mortarium* was finally removed from the top of US 6635. In fact, the top of this *mortarium* became visible in 2017, but until this year we had not reached the layer to which it belonged. Its removal allowed also to confirm its nature: the fragment is made up of its concave and roundish interior, part of its base, and part of the outside, still featuring one of its handles (6x7 cm) near the rim (Fig. 8). The *mortarium* was carved out of one piece of hard, white limestone. No marks are visible, but the lines of fracture appear to be neat, so the piece may be in primary deposition. Is it possible that this *mortarium* is somehow connected to the activities that happened in the *porticus* and/or rooms to the east?

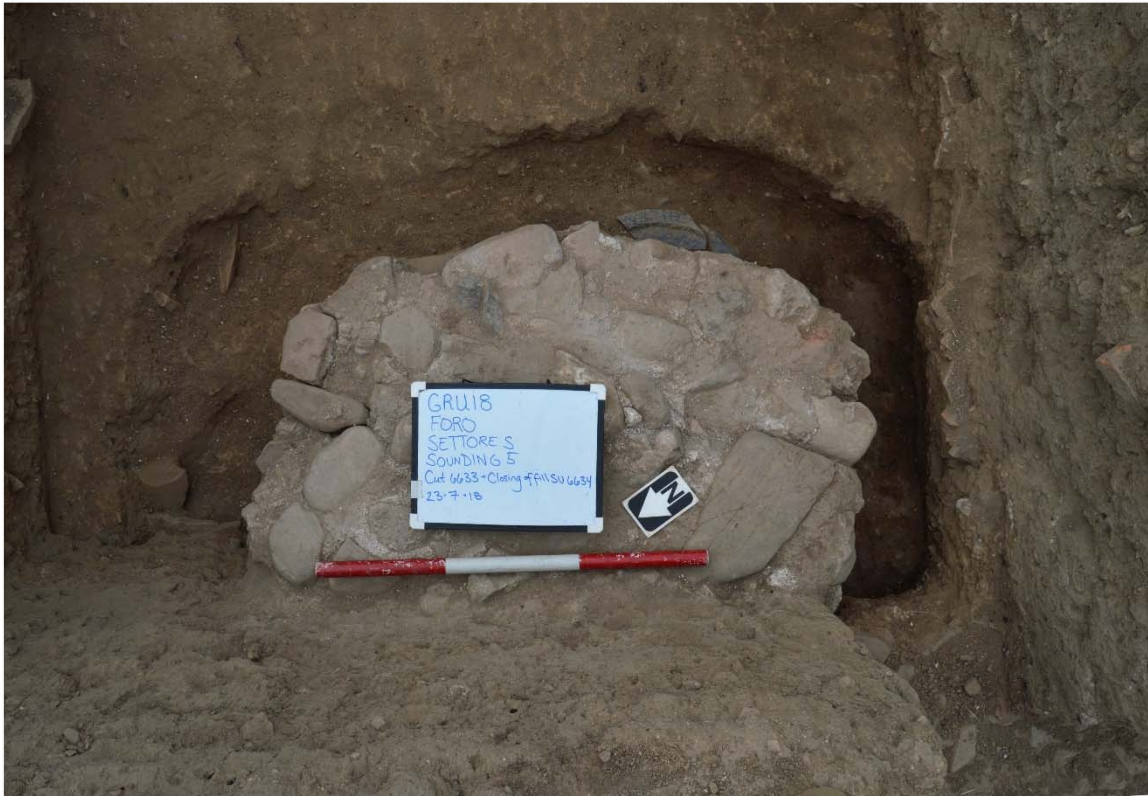
Fig. 9 Architectural feature 6421 surrounded by cut 6633. Remains of *vernice nera* plate visible in situ at upper right

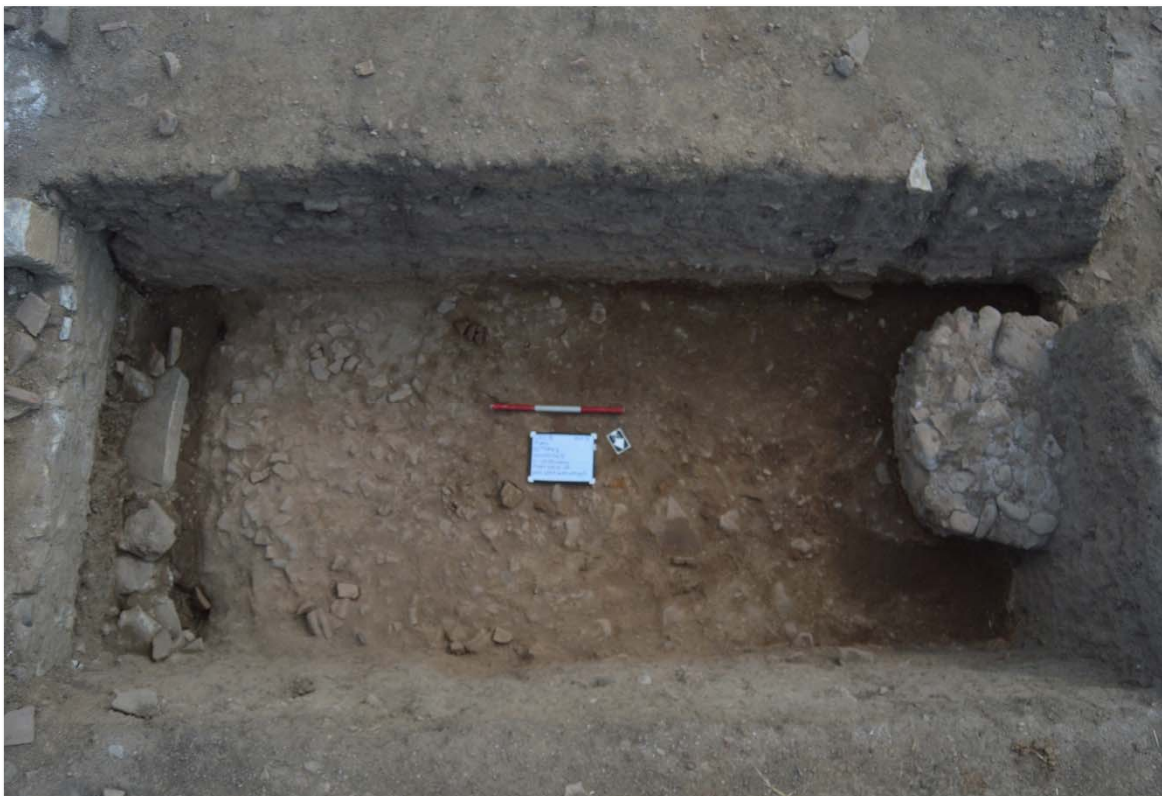
Fig. 10 Sounding 5 at the conclusion of the 2018 season. Wall 6540 visible at far left; architectural feature 6421 at far right

6421 may have functioned in conjunction with wall 6540, found in the eastern window during the 2017 campaign, but the precise relationship between the two architectural elements remains unclear (Fig. 10). There is not much new information regarding 6540, as excavation focussed on the western two-thirds of the sounding in 2018. However, it is clear that the pair were roughly coeval, as the construction trench of wall 6540 was cut through US 6535, the surface on which architectural feature 6421 was built. The relationship between these structures will be examined further during the 2019 campaign.

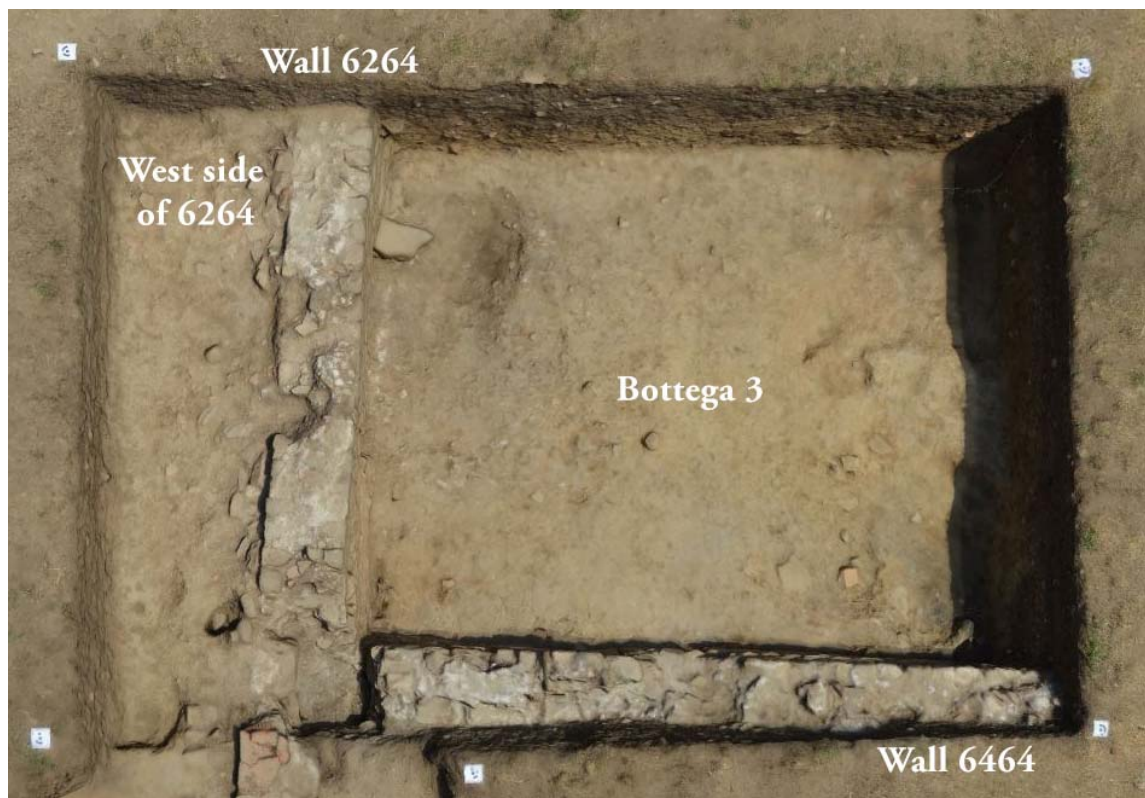
Fig. 11 Orthophoto of Sounding 7 at the conclusion of the 2018 season

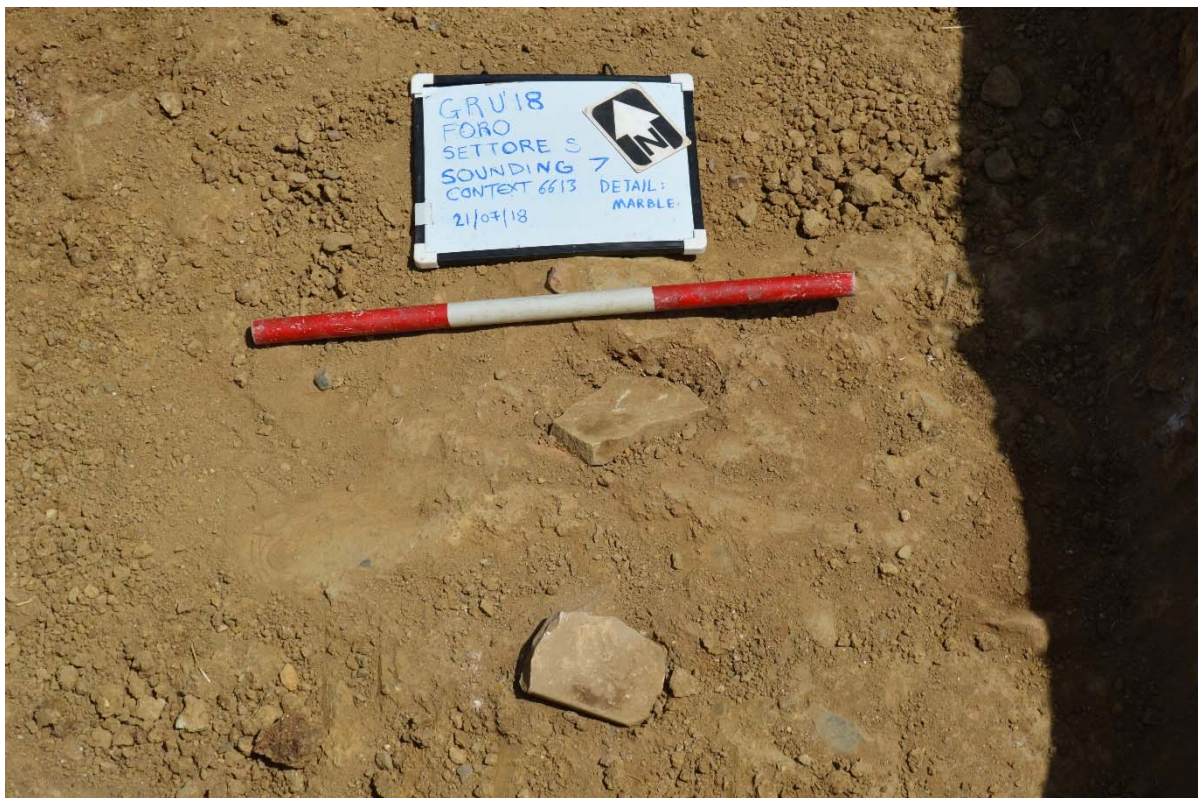
Fig. 13 Broken pieces of worked marble retrieved from US 6613

The cut US 6639 was filled with layer US 6613, a hard, light olive clay layer with scarce materials but containing two joining pieces of worked marble (Fig. 13). The fill strangely extended beyond the limits of the cut, forming a kind of platform raised above US 6624 by about 10 cm. The rest of the bottega was covered by US 6612, a brown silty clay layer, which seems to have been destruction or deconstruction layer, for it contained large pieces of tile and cut stone (similar to those used in wall 6264) laying more or less flat but at slightly different levels. This uneven deposition suggests that it was unlikely to be a walking surface. Some coins were also recovered, including one *sestertius* that could offer a *terminus post quem* for this layer; at present, however, it remains illegible.

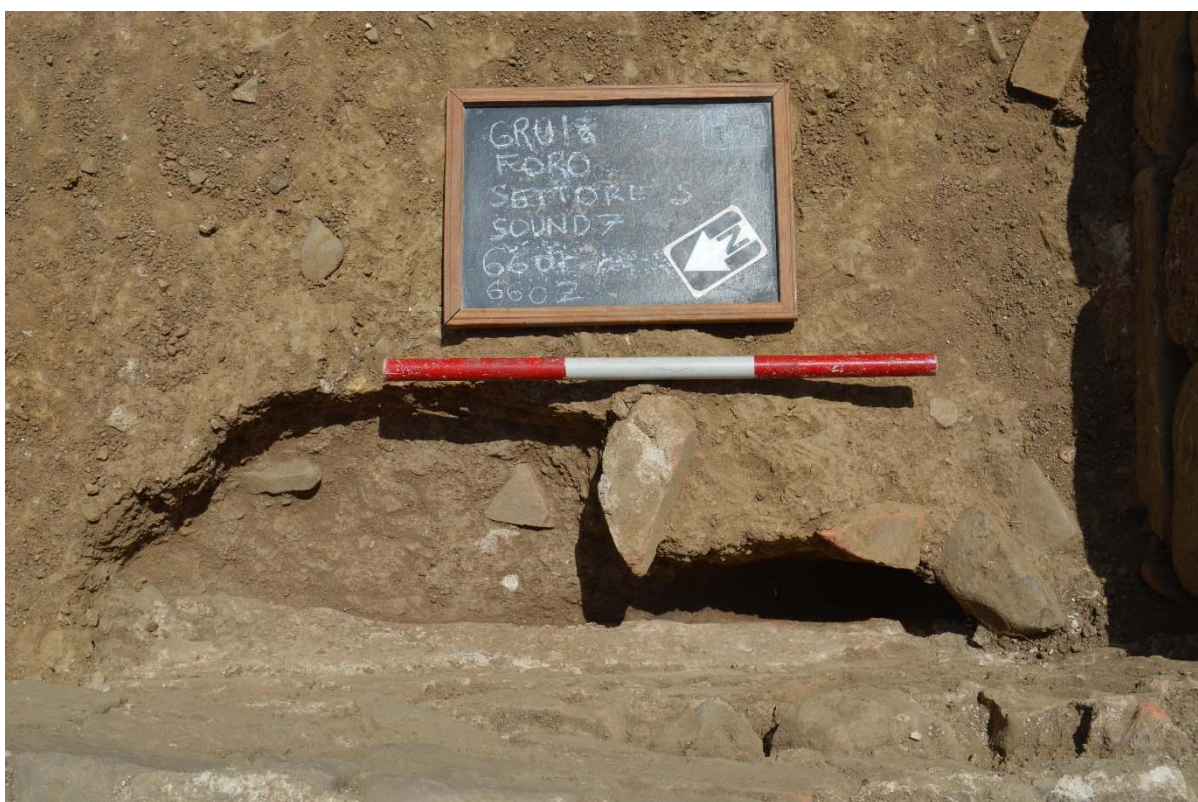
Fig. 14 Cut US 6602, located at junction of walls 6264 and 6583. The removal of fill US 6601 revealed the *opus signinum* plastering on the lower section of the 6583

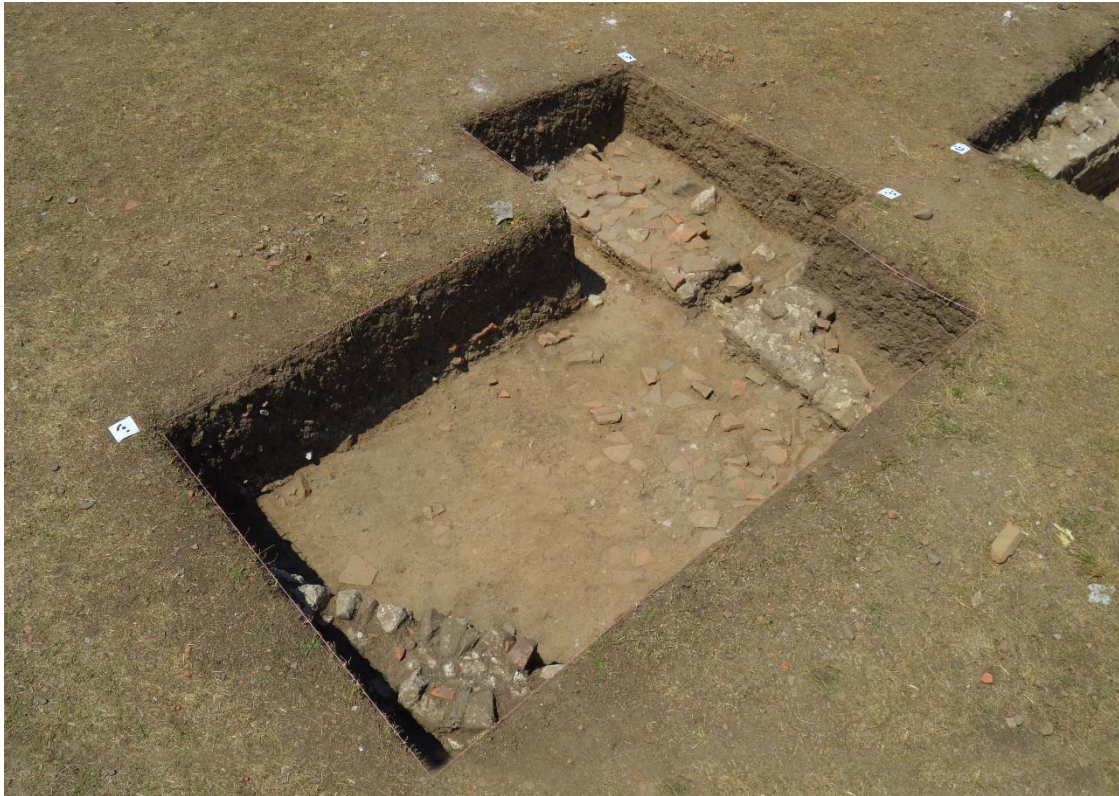
Fig. 15 Sounding 9 at the conclusion of the 2018 season; view from northeast. Wall 6561 visible towards the back of the trench

Sounding 9, located to the east of Botteghe 2 and 3, was opened in 2017 in order to find the back wall of these rooms (Fig. 3; Fig. 15). Below medieval agricultural fills (US 6201), this wall (US 6561) was successfully located in the northwest corner of the sounding. East of and abutting wall 6561, a multi-phase surface comprised of a layer of tile (US 6566) and mortar (US 6560) was also discovered.

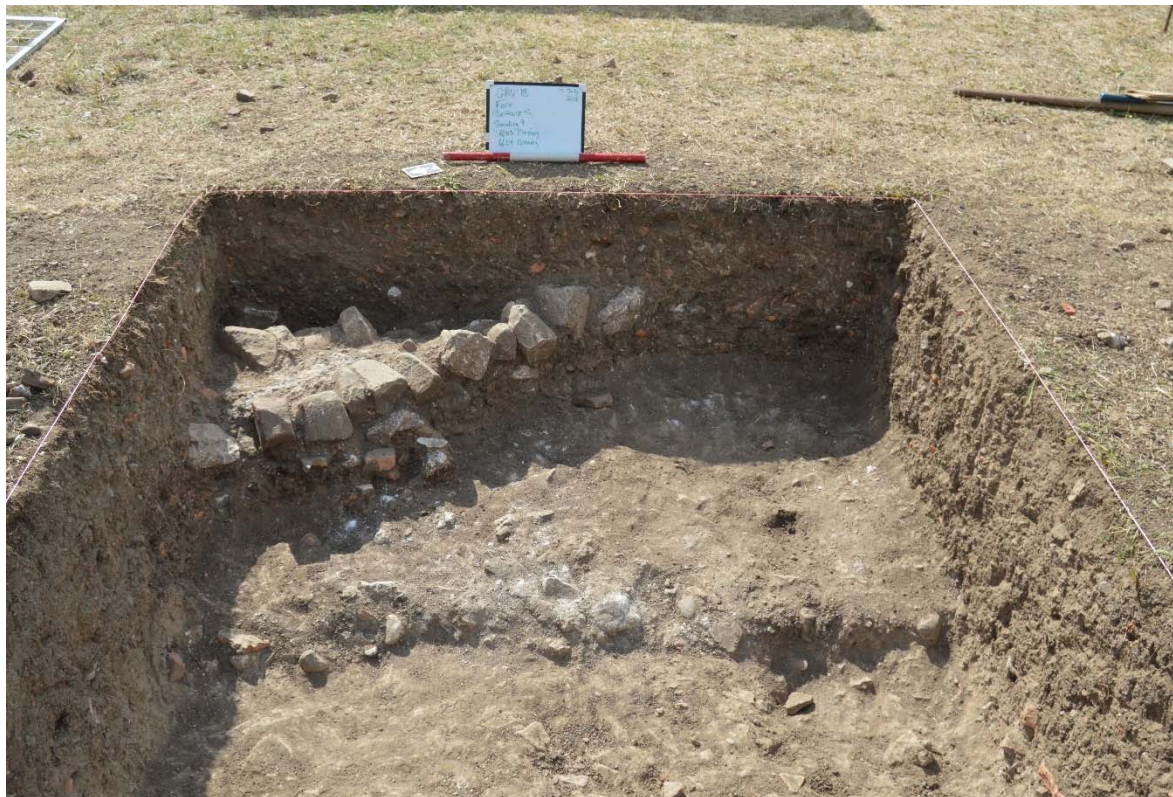
Fig. 16 Structure 6604, view from west

In Extension 1, below the compact medieval agricultural fills (US 6201), a stone and mortar feature (US 6604), likely a drainage channel, was discovered atop a second layer of agricultural fill (US 6603). This fill was similar in nature to US 6201, and was not identified elsewhere in the sounding; the only identifying distinction was the presence of the structure 6604 (Fig. 16). It is likely that US 6604 is early medieval, as it rests on soils approximately 30 cm above the late antique mortar surface US 6560. In Extension 2, the removal of US 6201 revealed the southerly continuation of mortar surface US 6560 and tile surface US 6578, as well as a yellow clay layer in the western third of the extension.

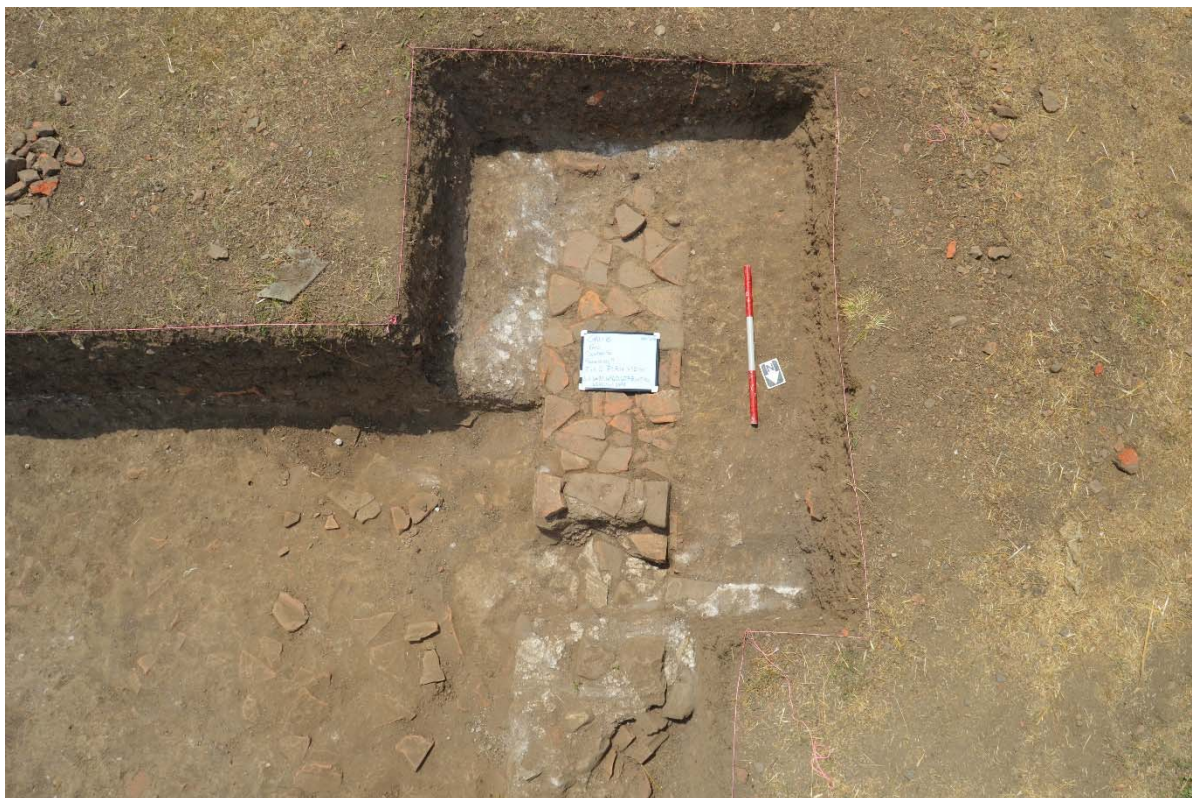
Fig. 17 Plan view of Sounding 9, Extension 2 depicting wall 6561

The oldest visible feature at the close of the 2018 season was wall 6561, for which a construction trench has not yet been identified (Fig. 17). Evidence for the later robbing of this wall was recognised in the northwest corner of the sounding (US 6599). Additionally, the wall appears to have been deliberately cut from west to east, in line with the junction of 6561 with wall 6464 (cut 6597; more on this below). The expansion of the sounding to the south revealed that wall 6561 continued southwards, and we now suspect that it represents one long, continuous structure, which established the rear wall of Botteghe 1 and 2. Excavations in this area also clarified the relationship between wall 6464—the partition between Botteghe 2 and 3—and wall 6561. It is now clear that the former postdates the latter, which confirms what we had expected all along: that the interior partition walls that divided the botteghe were installed after the building's superstructure (represented by wall 6583/6264 in the west and wall 6561 in the east) was erected.

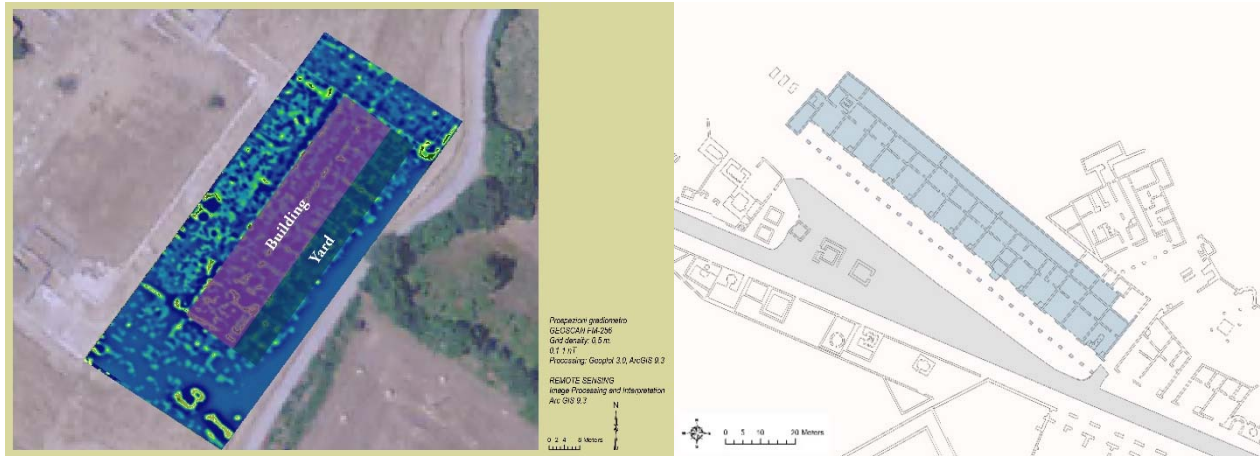
Fig. 19 Hypothetical reconstruction of building complex in Settore S (Option 1), left; so-called “Strip Building” at Pompeii, right (Pompeii GIS courtesy *Pompeii Bibliography and Mapping Project*)

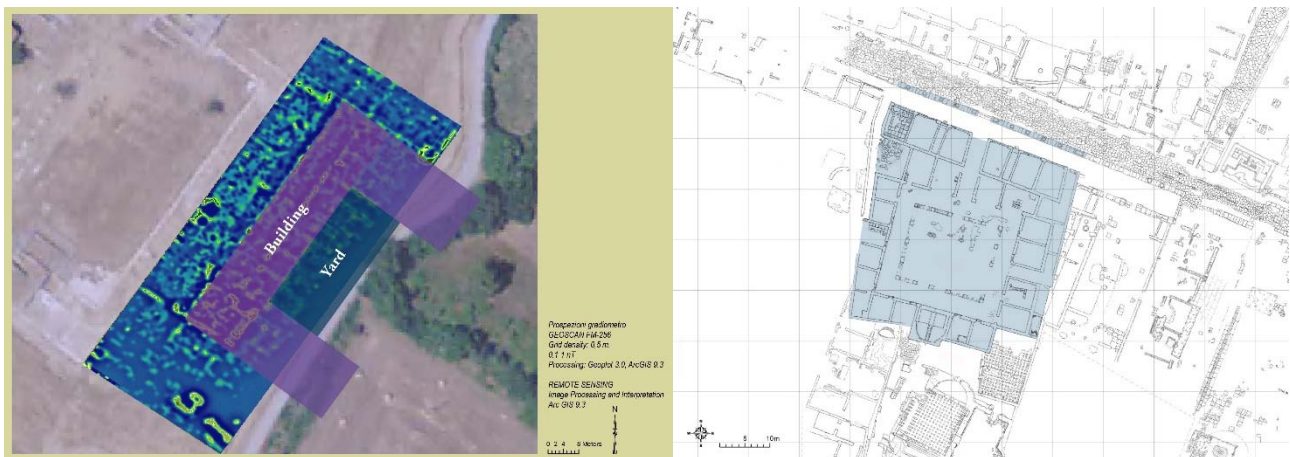
Fig. 20 Hypothetical reconstruction of building complex in Settore S (Option 2), left; *macellum* at Minturnae, right (*macellum* plan after Bellini and von Hesberg, 2015, Fig. 1)¹
